**DEPARTMENT OF TRANSPORTATION**

Contract #: 04-0120F4Cty: SF/ALA Rte: 80 PM: 13.2/13.9File #: 69.28**WELDING INSPECTION REPORT****Resident Engineer:** Pursell, Gary**Address:** 333 Burma Road**City:** Oakland, CA 94607**Report No:** WIR-003279**Date Inspected:** 09-Jul-2008**Project Name:** SAS Superstructure**OSM Arrival Time:** 1400**Prime Contractor:** American Bridge/Fluor Enterprises, a JV**OSM Departure Time:** 2330**Contractor:** Zhenhua Port Machinery Company, Ltd (ZPMC), Changxing Island **Location:** Shanghai, China**CWI Name:** Li Yanhua**CWI Present:** Yes No**Inspected CWI report:** Yes No N/A**Rod Oven in Use:** Yes No N/A**Electrode to specification:** Yes No N/A**Weld Procedures Followed:** Yes No N/A**Qualified Welders:** Yes No N/A**Verified Joint Fit-up:** Yes No N/A**Approved Drawings:** Yes No N/A**Approved WPS:** Yes No N/A**Delayed / Cancelled:** Yes No N/A**Bridge No:** 34-0006**Component:** OBG**Summary of Items Observed:**

## WELDING INSPECTION REPORT

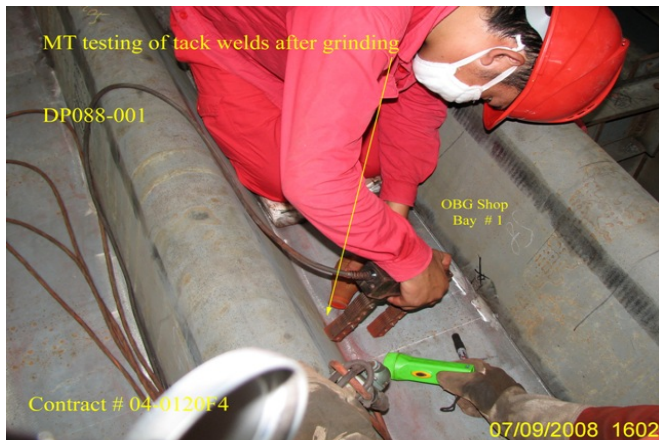
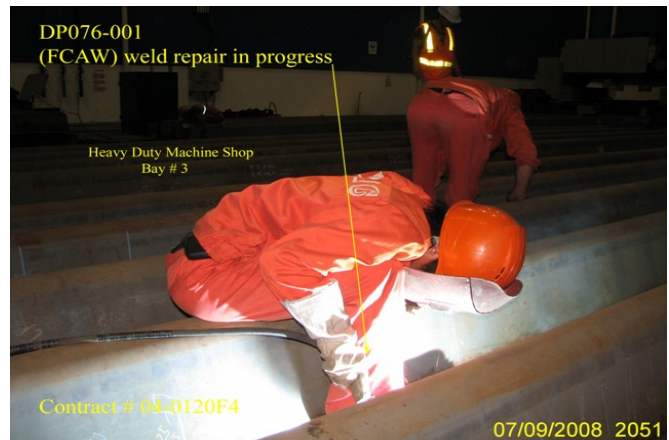
The QA Inspector observed Mr. Cai Xin Xin of ZPMC performing Magnetic Particle Testing (MT) on deck panel DP088-001, a total of 81 cracks were found during the initial MT testing. The cracks were removed with a grinder and another MT test was performed.

Mr. Xin informed the QA Inspector that no indications were found during the second MT inspection.

The QA Inspector observed deck panel DP358-001 idle at Gantry #1 (SAW) welding was completed, DP439-001 and DP142-001 were idle at Gantry #2 and (SAW) welding was completed.
